# Route 146 Corridor Study

Town of Branford

Town of Guilford

Issued: July 31, 2021

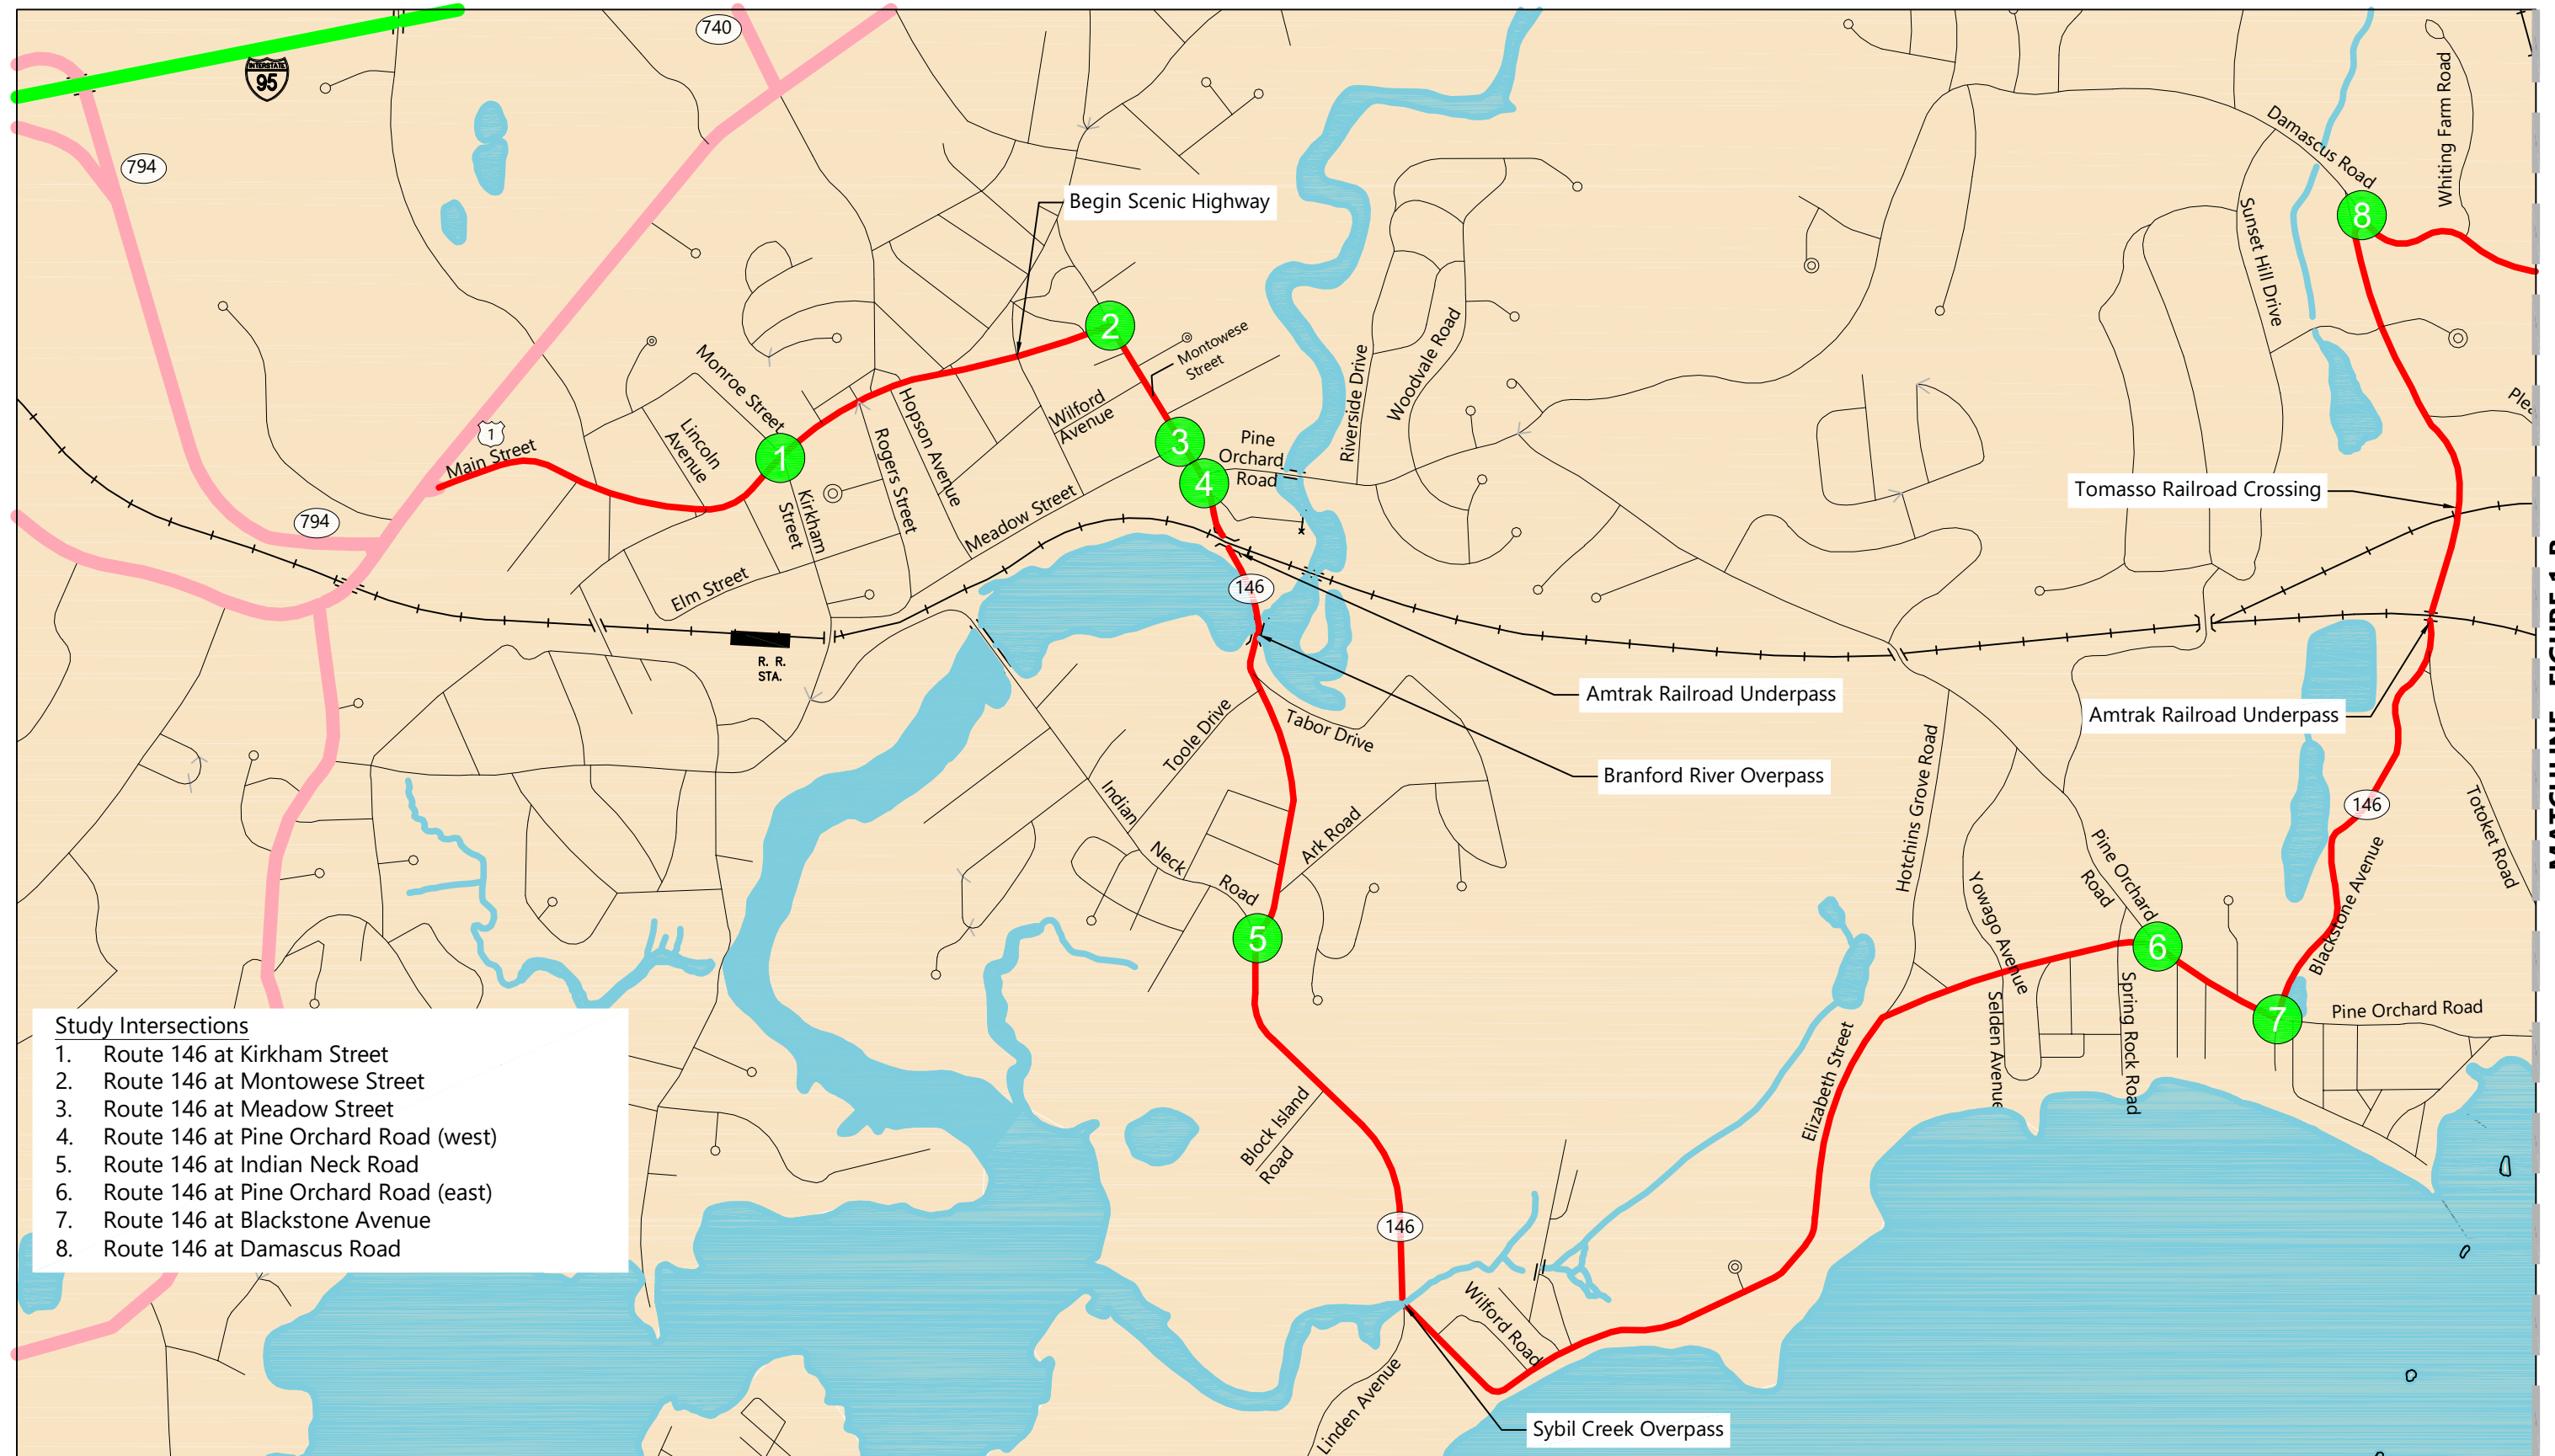
**Figure 1-A**  
Nov. 2020

- Study Intersections**
1. Route 146 at Kirkham Street
  2. Route 146 at Montowese Street
  3. Route 146 at Meadow Street
  4. Route 146 at Pine Orchard Road (west)
  5. Route 146 at Indian Neck Road
  6. Route 146 at Pine Orchard Road (east)
  7. Route 146 at Blackstone Avenue
  8. Route 146 at Damascus Road

The project study area includes 14 total intersections, all of which are unsignalized intersections except one at Kirkham Street. There is a flashing beacon with stop sign control at the intersection of Soundview Road at Goose Lane in Guilford. These 14 intersections were chosen as study intersections to be investigated in greater detail. The limits of the project study area and the study intersections are identified on Figures 1A-1C.

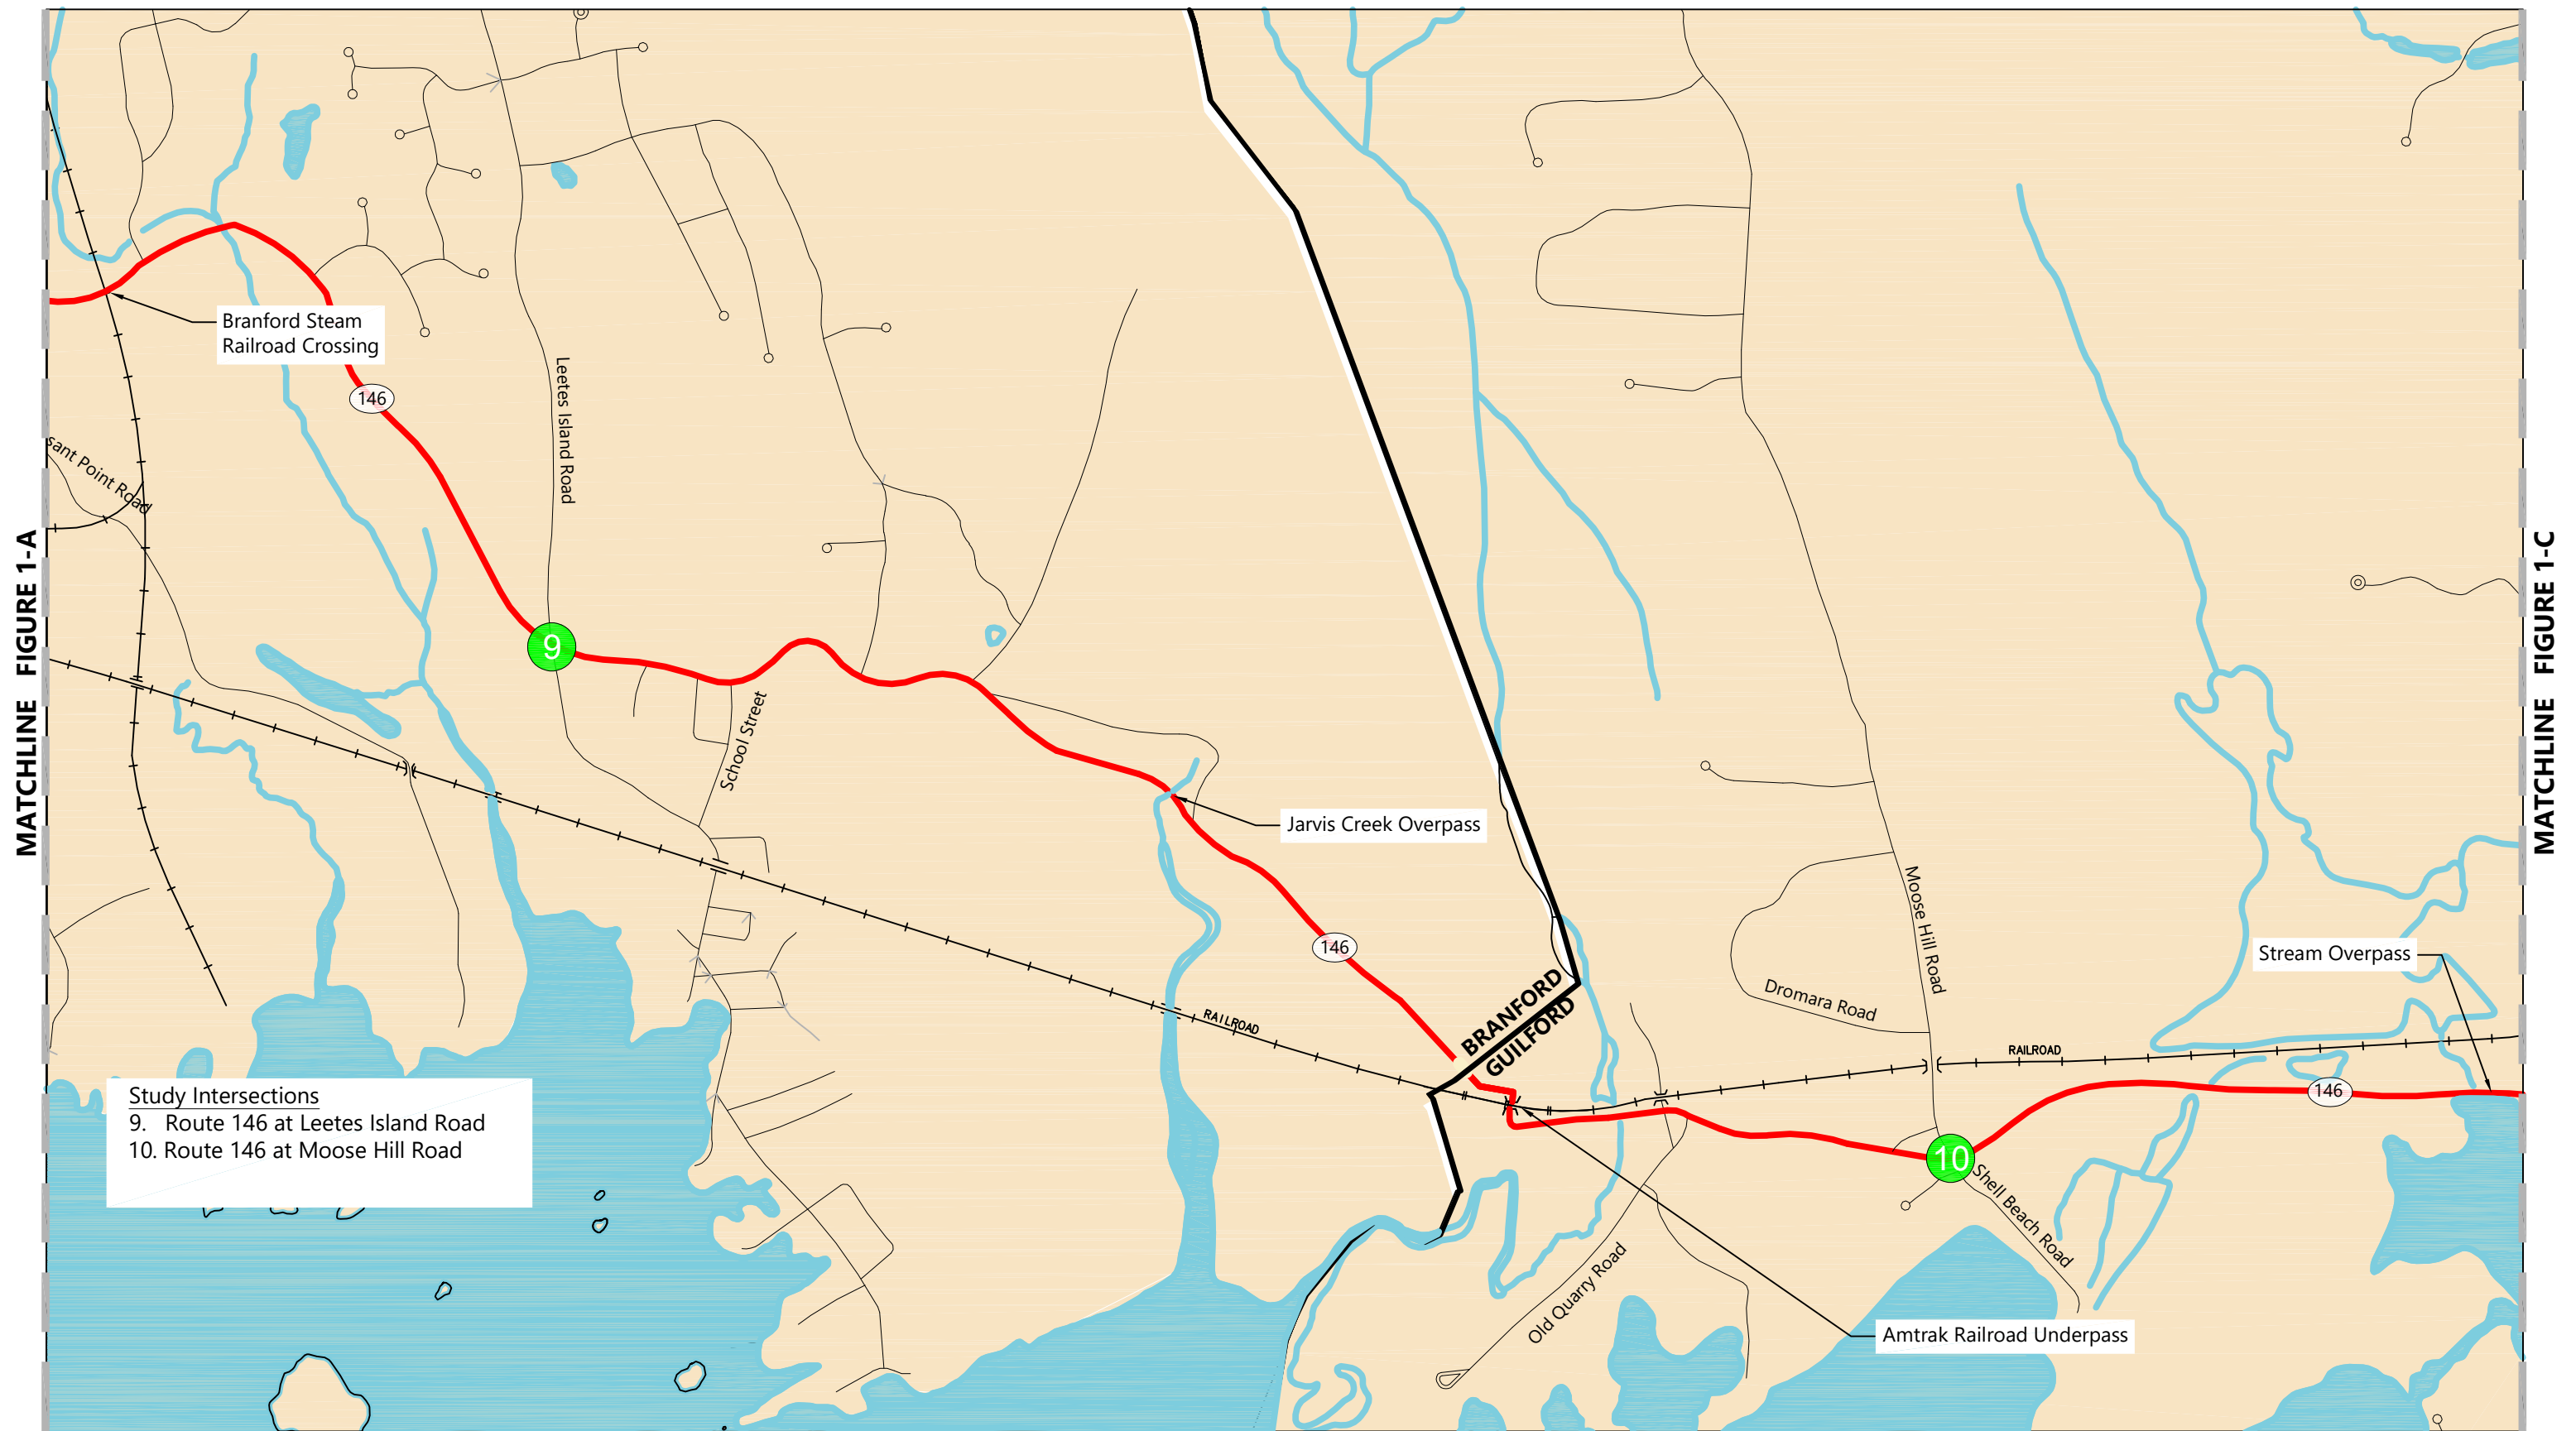
**Study Intersections**  
9. Route 146 at Leetes Island Road  
10. Route 146 at Moose Hill Road

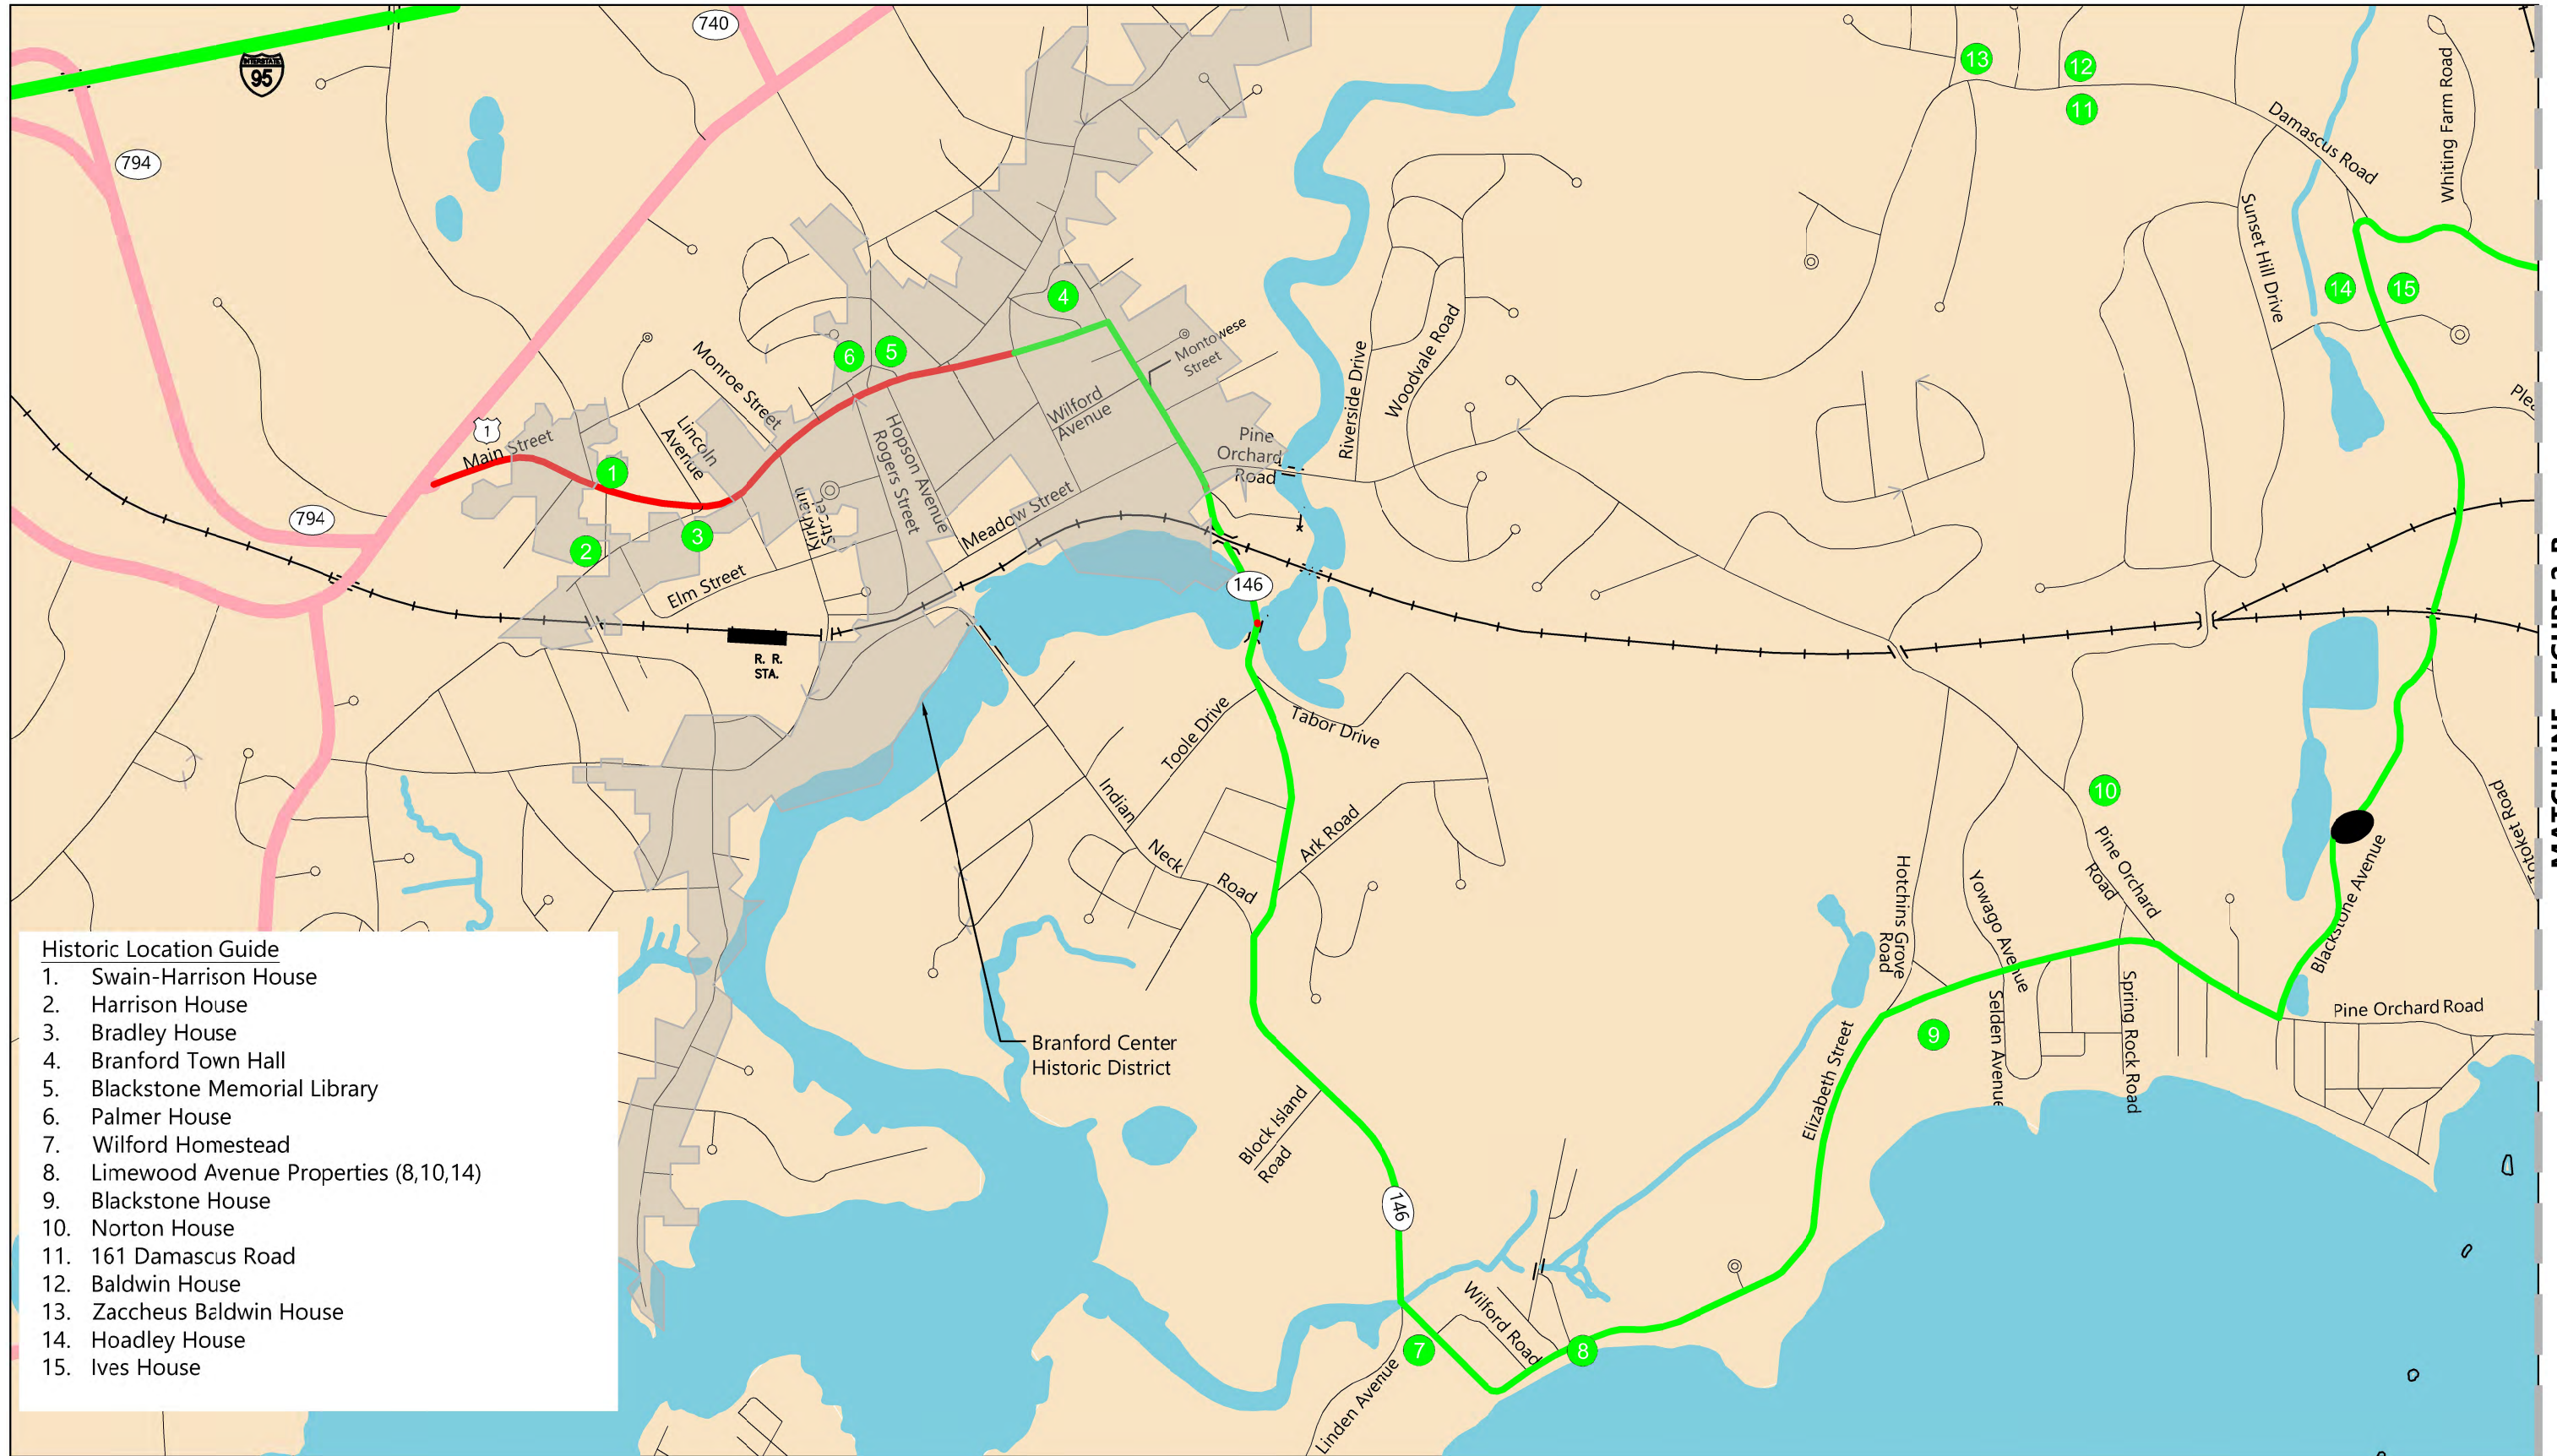
- Historic Location Guide**
1. Swain-Harrison House
  2. Harrison House
  3. Bradley House
  4. Branford Town Hall
  5. Blackstone Memorial Library
  6. Palmer House
  7. Wilford Homestead
  8. Limewood Avenue Properties (8,10,14)
  9. Blackstone House
  10. Norton House
  11. 161 Damascus Road
  12. Baldwin House
  13. Zaccheus Baldwin House
  14. Hoadley House
  15. Ives House

Figures 2A through 2C indicate the locations of the recorded historically designated properties along the Route 146 corridor. Figures 3A through 3C indicate the locations of the noted cultural spots along the Route 146 corridor.

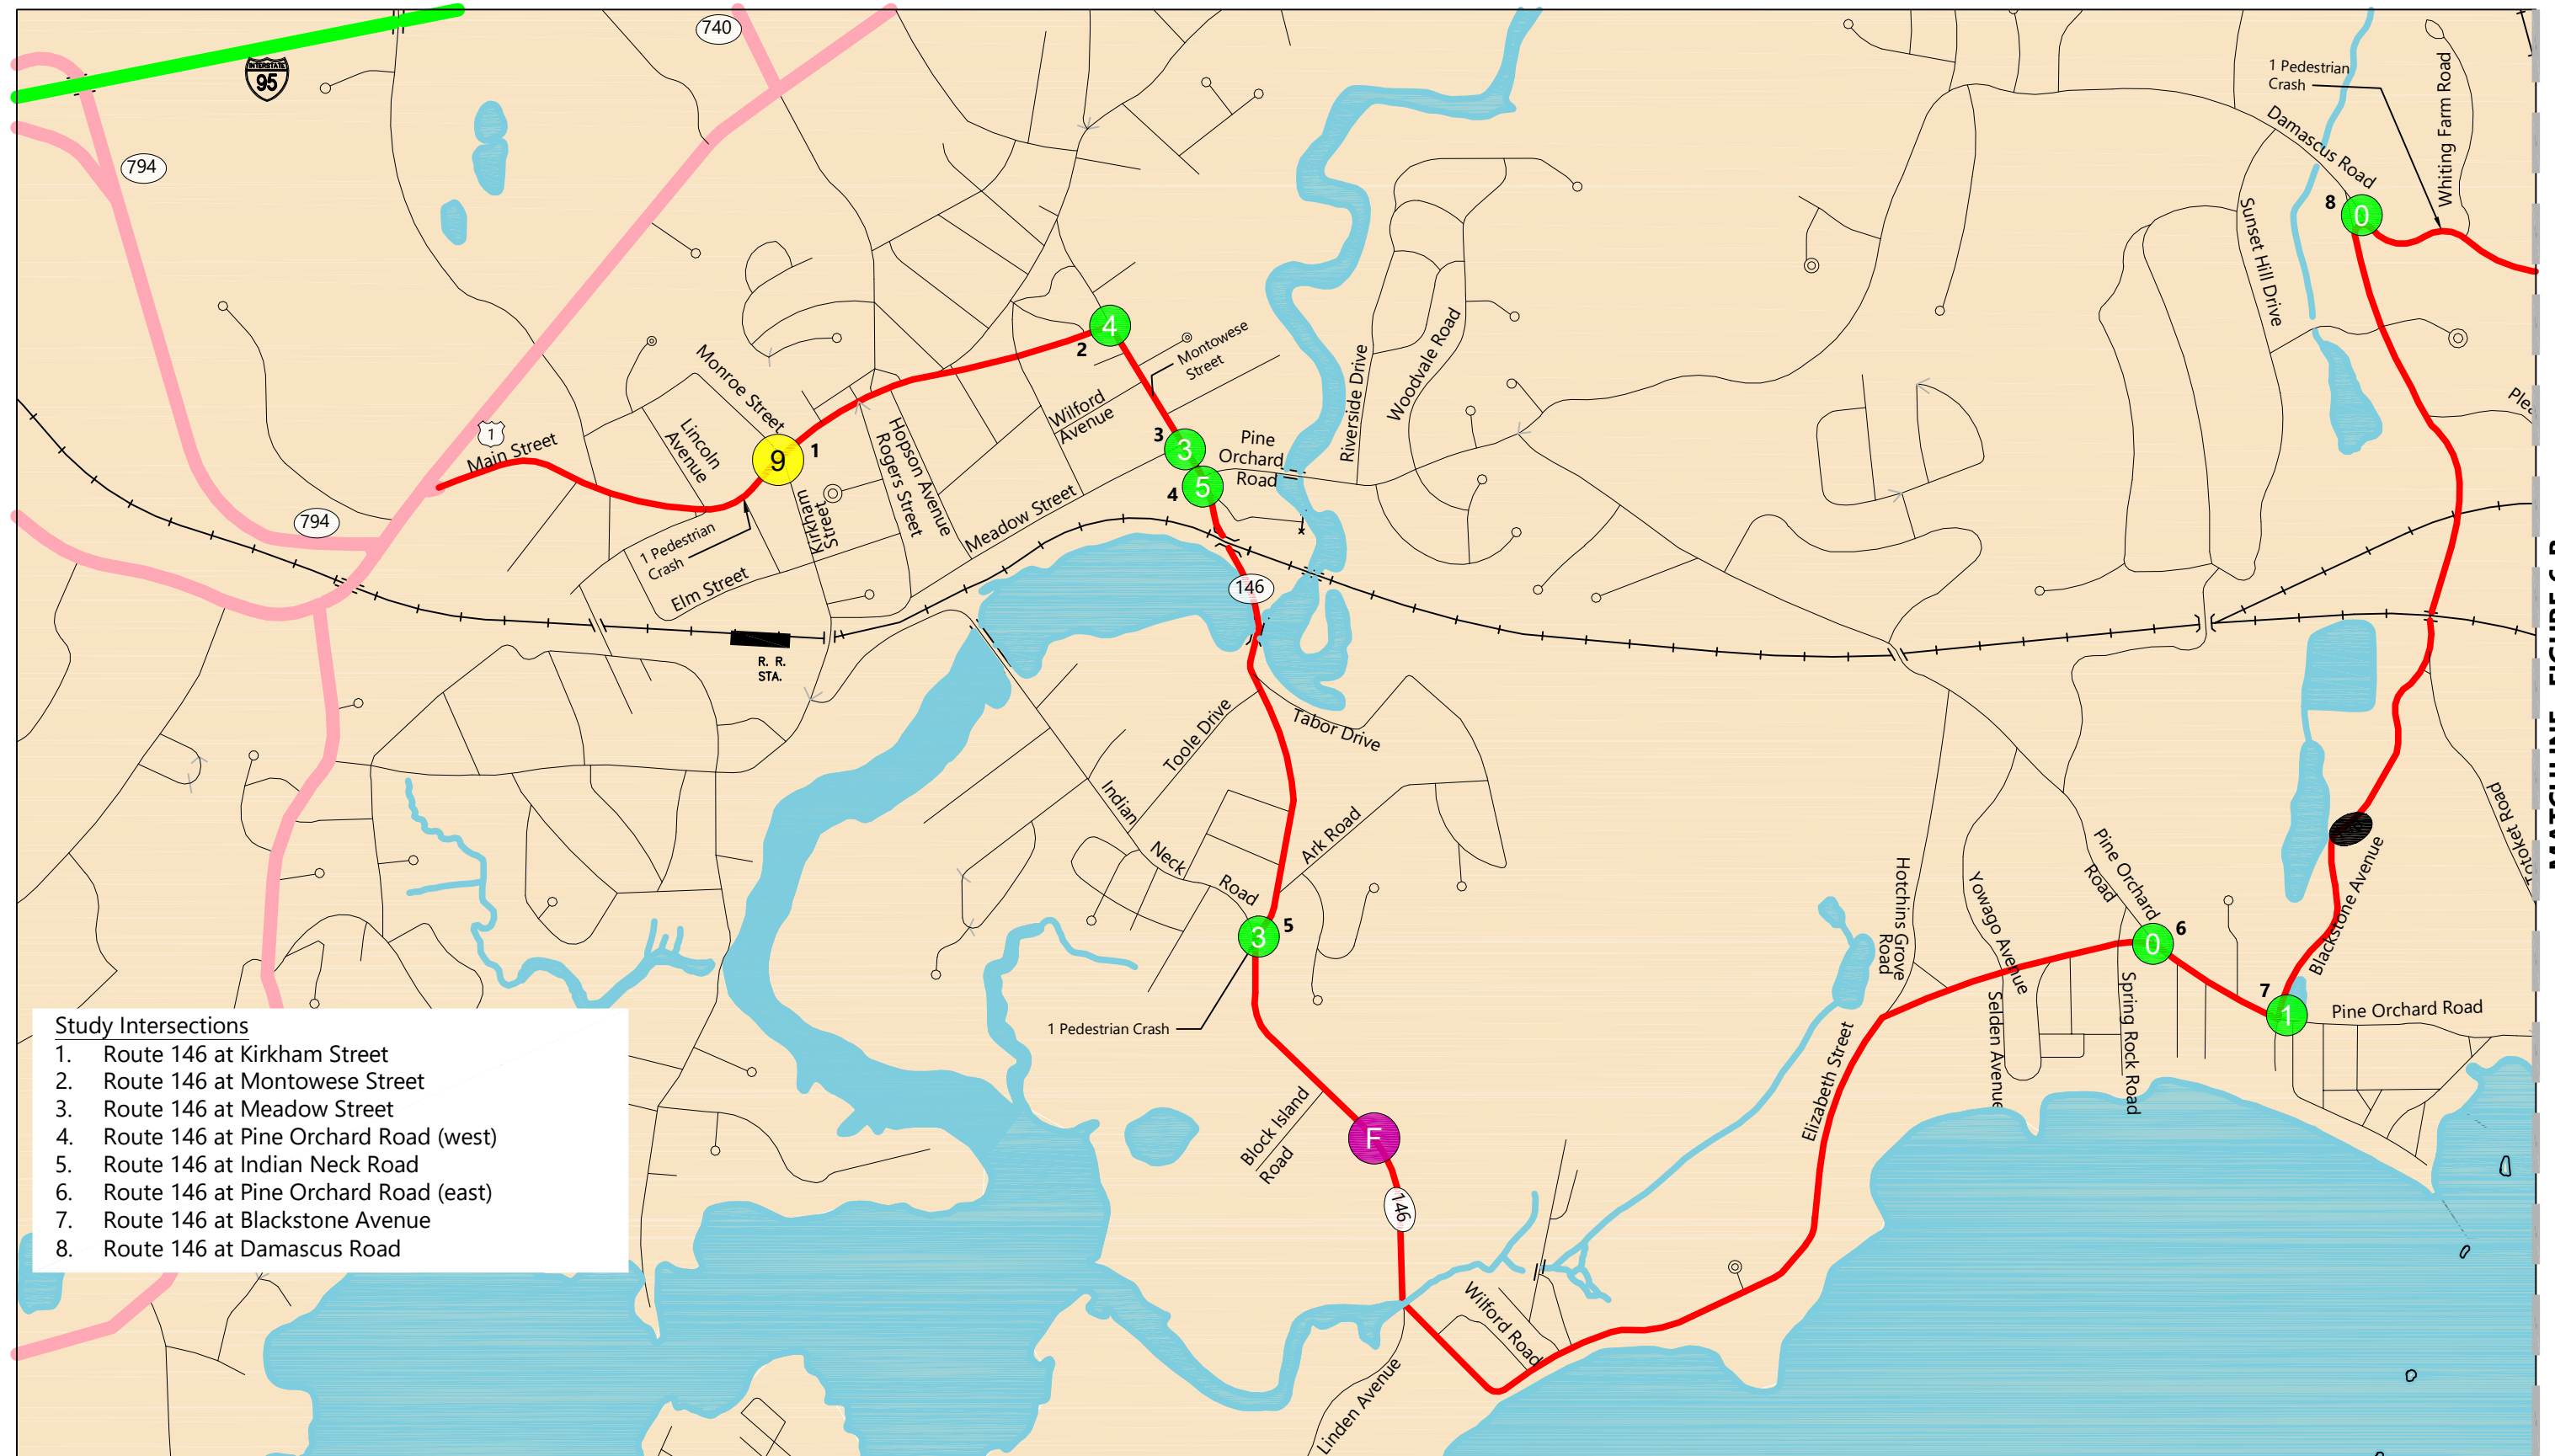
**Figure 6-A**  
Nov. 2020

- Study Intersections**
1. Route 146 at Kirkham Street
  2. Route 146 at Montowese Street
  3. Route 146 at Meadow Street
  4. Route 146 at Pine Orchard Road (west)
  5. Route 146 at Indian Neck Road
  6. Route 146 at Pine Orchard Road (east)
  7. Route 146 at Blackstone Avenue
  8. Route 146 at Damascus Road

**LEGEND**  
Number of Crashes Per Intersection

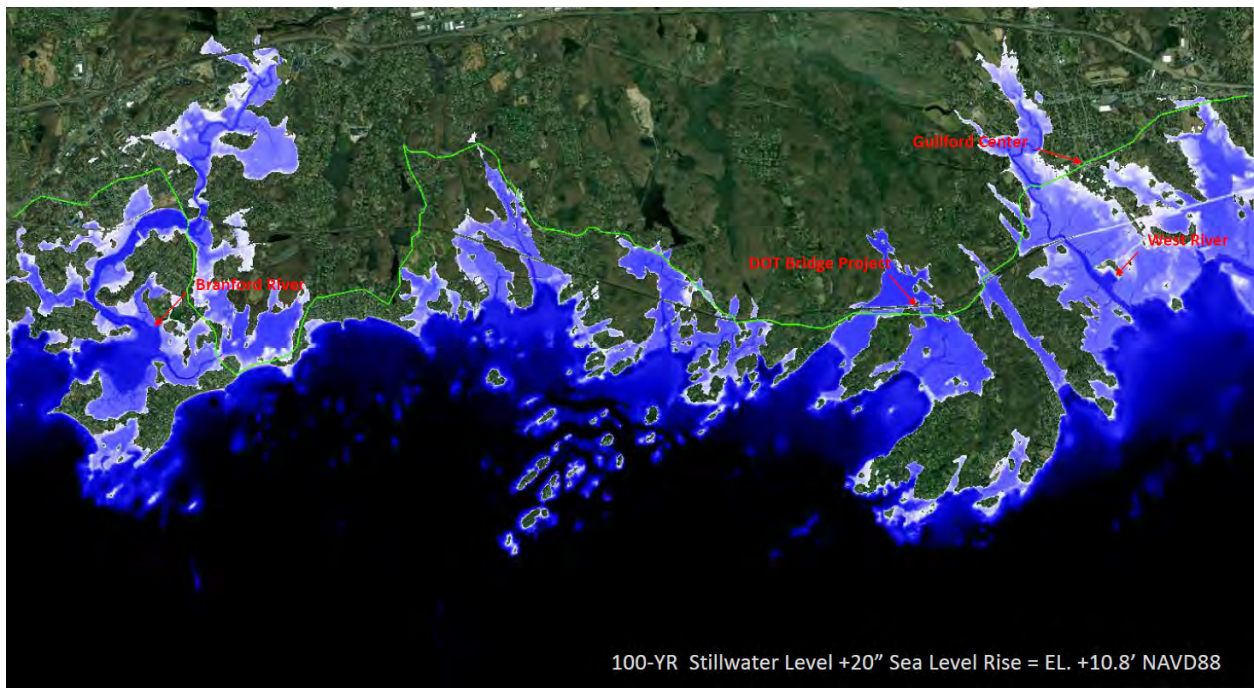
Figure 22: 100-yr Stillwater Level +20" of SLR = El. +10.8'
