Route 146

CORRIDOR MANAGEMENT PLAN

MARCH 2025

PREPARED FOR
Connecticut Department
of Transportation
Bureau of Policy and Planning

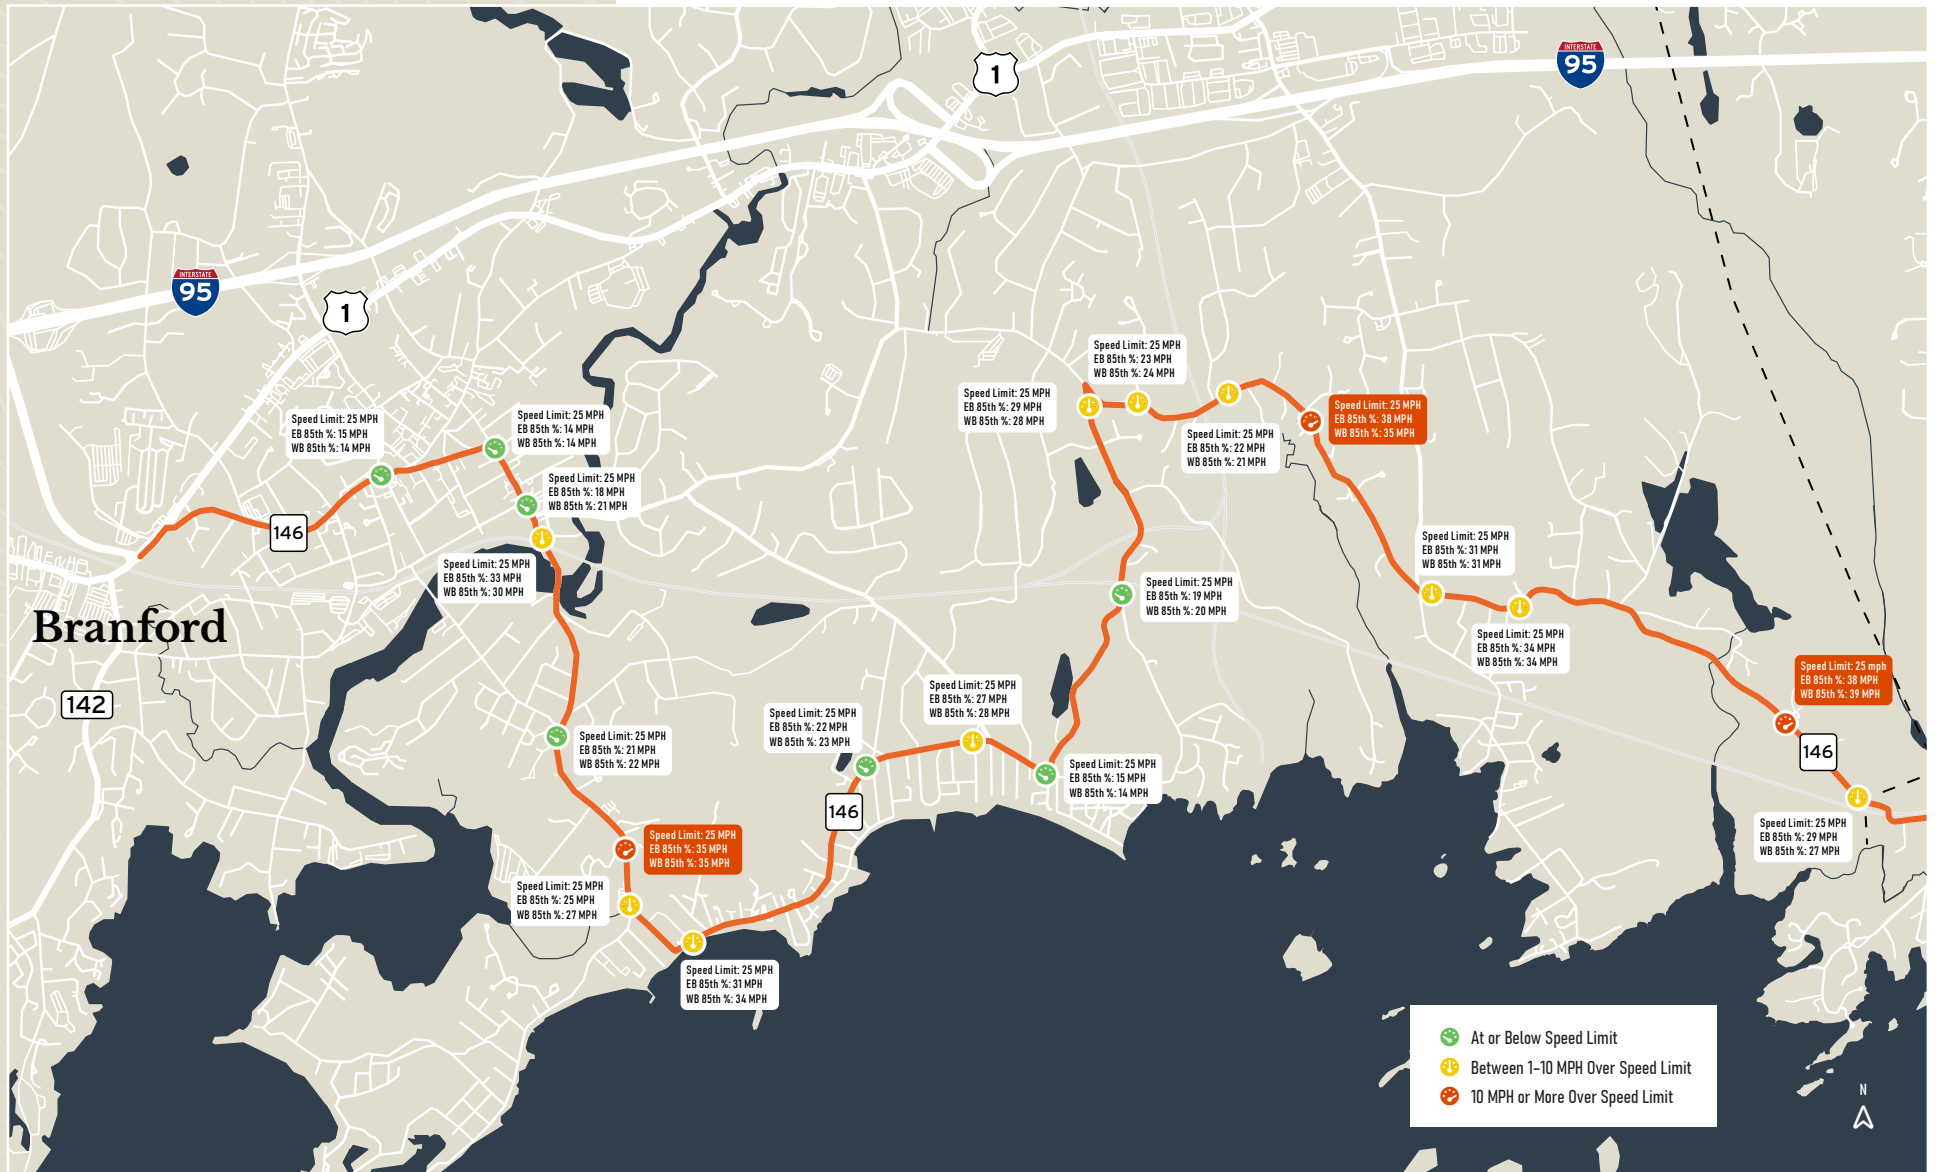
Route 146 Vehicle Speeds Branford

Drivers speeding came up frequently during the public comment, in the stakeholder interviews, and with the CWG. The local police departments of Branford and Guilford noted areas where they had received speeding complaints and often do traffic speed enforcement. Locations with excessive speeding—85th percentile speeds of drivers going at least 10 miles per hour or more over the speed limit—were found South of Sybil Creek Place and east of Pine Tree Drive, both in Branford. The speeding south of Sybil Creek Place was identified as a concern by the public due to the presence of pedestrians around the restaurants and entertainment area of Indian Neck, which lacks a complete pedestrian network. Route 146 east of Pine Tree Drive in Branford has sharp curves, poor sightlines, and narrow paved shoulders which increase the crash risk of speeding. Excessive speeding was also found at the new locations where data was collected, 710 Leetes Island Road in Branford and 444 Leetes Island Road in Guilford, which confirmed the data and observations of the two police departments. These second two locations with excessive speeding were in places with lower densities, straight roadways with limited obstructions, and low turning traffic. See **Figures 2.1 and 2.2** for maps of the locations of speed data collected and where excessive speeding was recorded.

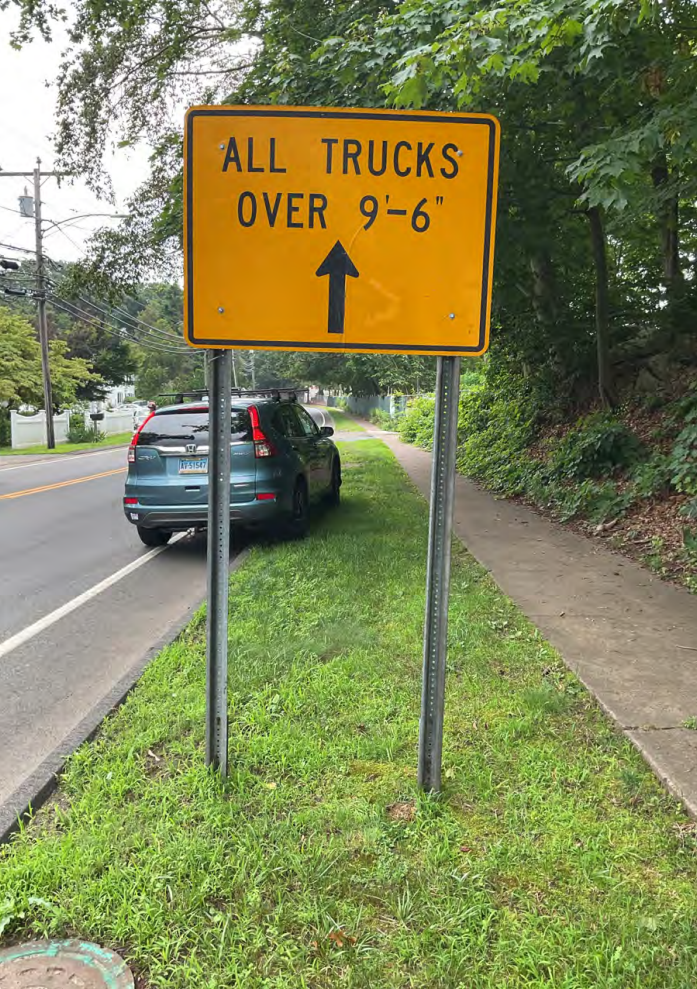
Low clearance sign, South Montowese Street at Indian Neck Avenue, Branford, summer 2023 (VHB)
